Logitech K830 Repair USB connector Replacement

Written By: mathieubernou

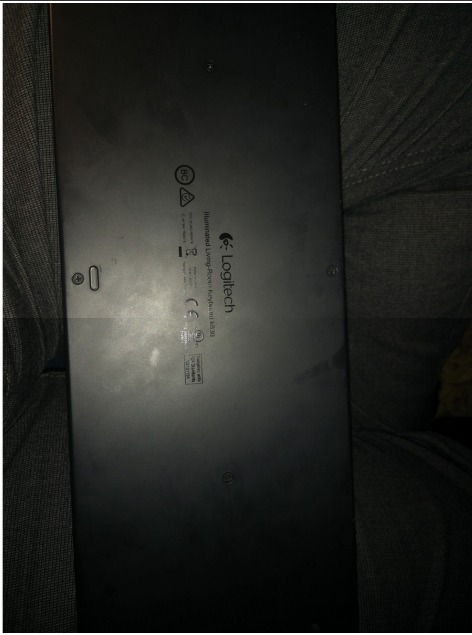
Step 1 — Repair USB connector

- Turn the keyboard. Back facing up
